## Black locust

## Black locust and WholeTrees®

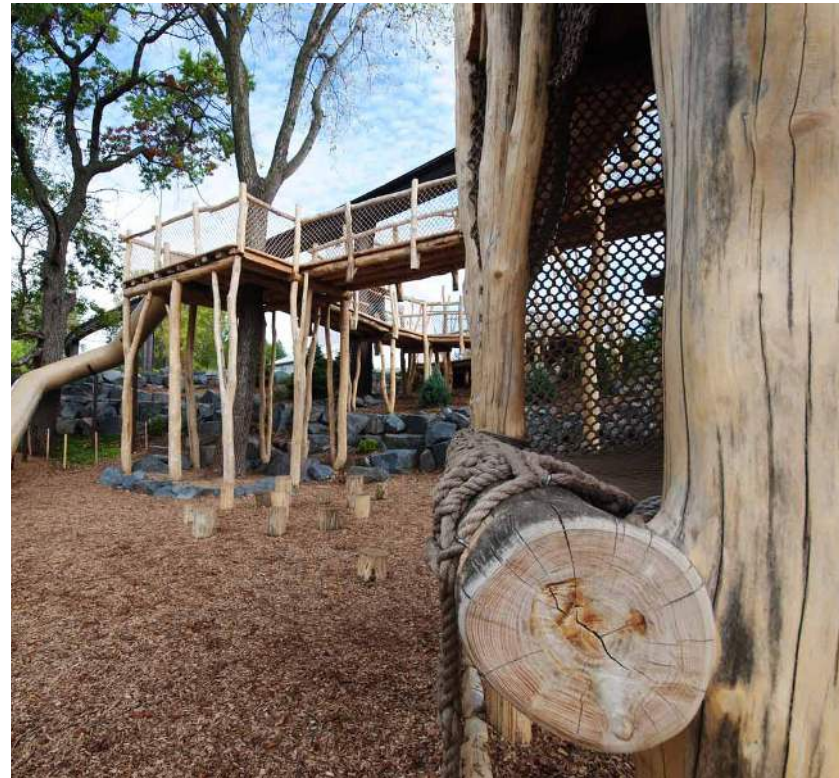
Figure 1. A Black locust tree walk with a hemp-oil based finish, two months after initial application.

Regardless of finish selection, WholeTrees recommends following manufacturer's instructions for maintenance. WholeTrees advises cleaning the structure and reapplying finish, every 1-5 years depending on conditions.

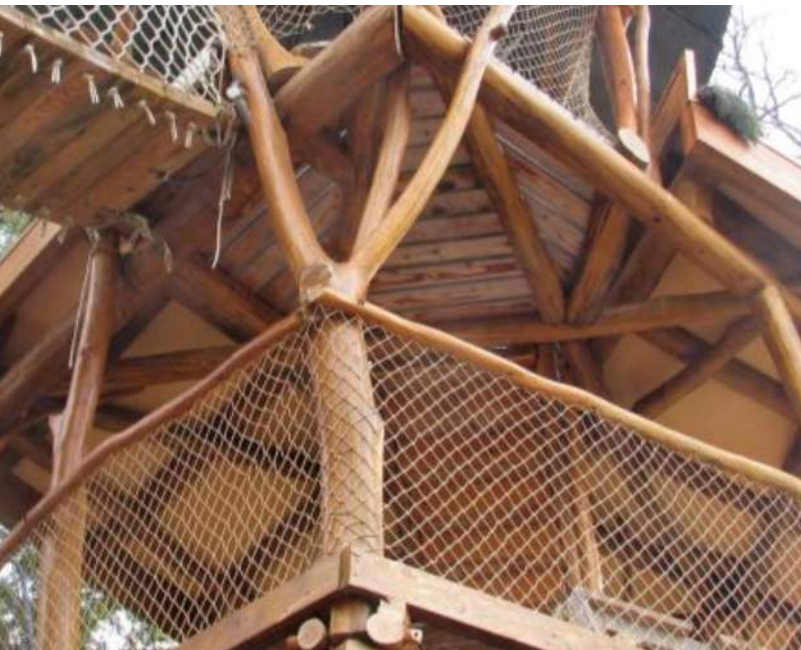
*Figure 2. Black locust with a tinted finish, approx. two years after initial application.*

Freshly peeled black locust is a light “blond” color. The wood is also known to develop black specks or streaks from contact with higher environmental humidity conditions. Occasional black ‘blooms’ occur in extremely moist and shady locations. These surface-level effects may be considered unappealing and do not impact the integrity of the wood. Though exact reasons are not clear, black locust experts theorize this to be a result of natural disease-resistant components of the wood (flavenoids) interacting with the finish in higher humidity conditions. Please contact WholeTrees for help if a diagnosis is necessary, and then an appropriate treatment plan can be developed to treat the surface.

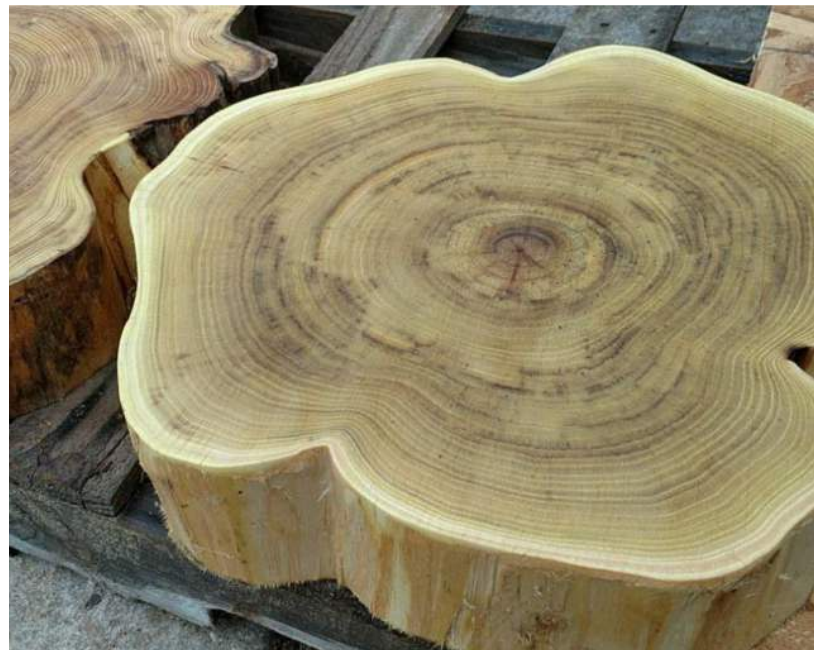
*Figure 3. A Black locust tree slice with oiled finish at initial application.*

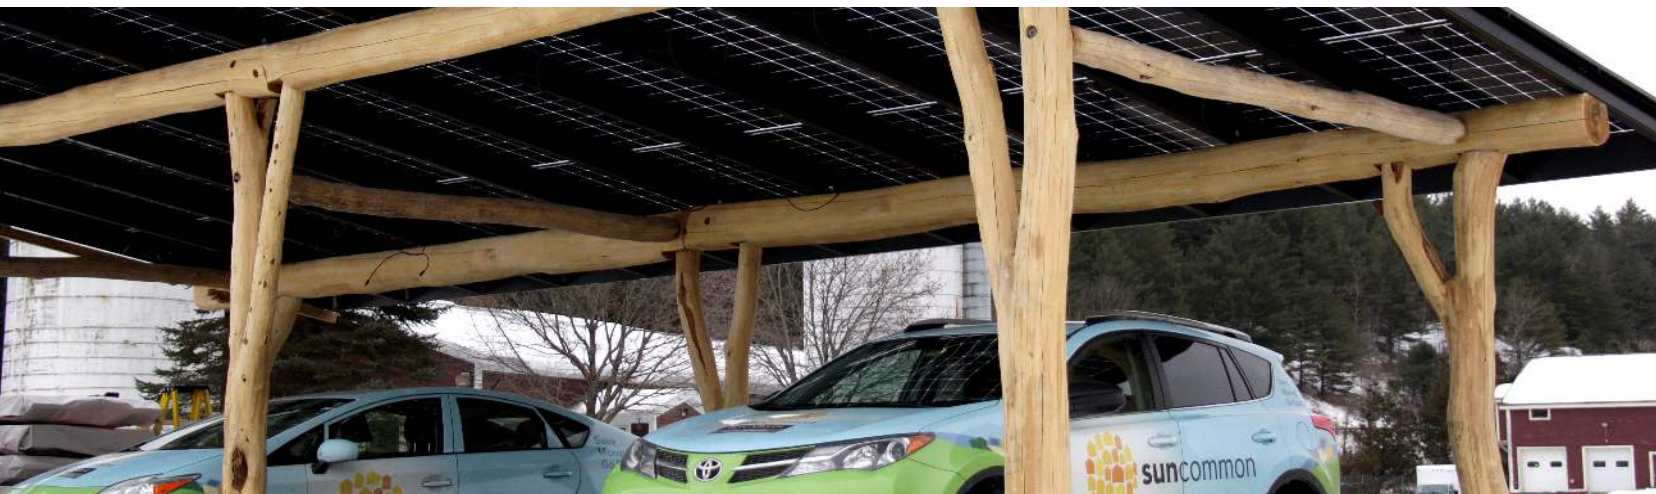
*Figure 4. Black locust solar carport with a linseed based finish, approx. one month after initial application.*
